Original Article

# Development of Self-Healing Concrete Using Synthetic Fiber Reinforcement

Soleen Jaber Ahmad Al-Hasan<sup>1</sup>, Balamuralikrishnan R<sup>2</sup>, Mohammad Moosa<sup>3</sup>

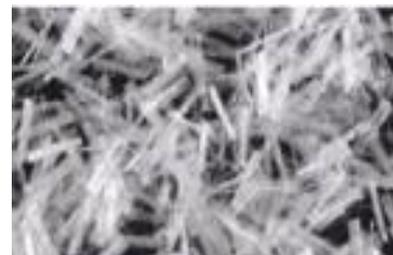
**Fig. 1 Microscopic view of Weber. ad M synthetic fibers**

Colour	White
S.G	0.91
Constituents	Virgin Polypropylene
Fiber thickness	18-30 micron
Melting point	> 160°
Alkali & salt resistance	High
Modulus of elasticity	500 ksi
Absorption	None

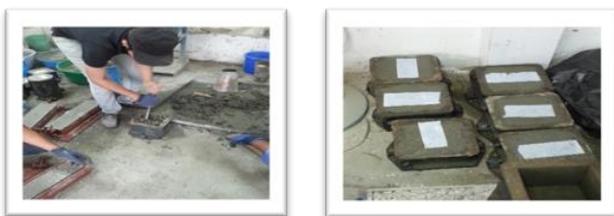
Fig. 2 Casting the samples

The study originally planned to include three samples per mix, but this number was increased to enhance the dependability of the findings. A total of six cubes were produced for each mix type, the control mix, and those containing 20 g, 30 g, and 40 g of fibres, giving 24 specimens overall. All batches were cast and cured following identical procedures. Each specimen was formed in a 150 mm × 150 mm cube mould and left to set for one day. After demoulding, the cubes were placed in a curing tank and submerged for a 28-day curing period (Figure 2).

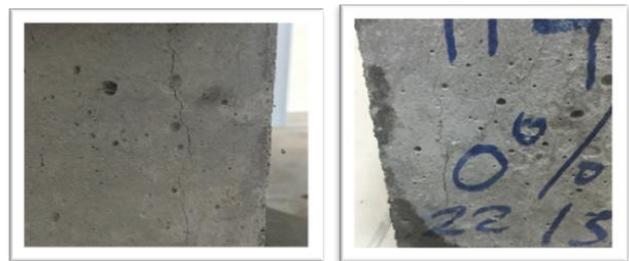
Fig. 3 Cracks formed on the samples

After curing for 15 days, the specimens were removed from the water tanks and transferred to the UTM facility. A compression testing machine was then used to introduce controlled cracks in the concrete cubes.

The setup was similar to a standard compressive strength test, but the loading was halted immediately once surface cracks became noticeable on each sample (Figure 3). Following crack formation, the specimens were returned to the curing tank for an additional 14 days before proceeding to the final phase of the study, the water-permeability assessment.

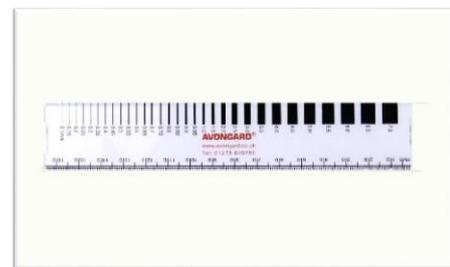
Fig. 4 Crack width gauge apparatus

After the cracks were formed in the samples, their widths were measured to allow comparison later and to determine whether any reduction occurred. A crack-width gauge was used for these measurements (Figure 4). The measurement point was first selected on a straight section of the crack, ensuring proper alignment with the gauge.

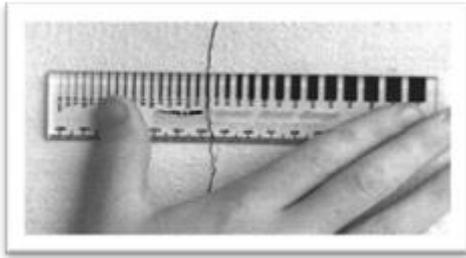
Fig. 5 Crack measurement method

The gauge was then placed against the specimen surface and adjusted until its calibrated scale aligned precisely with the crack edges. Once properly positioned, the crack width was read from the scale and recorded (Figure 5).

Most of the cracks observed in the specimens were within the range of 0.1–0.2 mm. In a few cases, partial failure during the compressive strength test produced wider cracks measuring approximately 0.5–0.9 mm. Cracks of this magnitude fall outside the healable range and are not expected to undergo any self-healing.

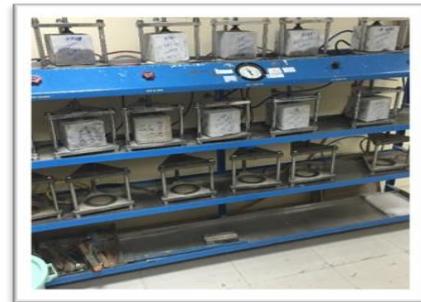
Fig. 6 Water permeability apparatus

The water-permeability procedure is carried out on concrete cubes or cylindrical samples to assess how far pressurised water can infiltrate the material. Cube specimens are typically at least 150 mm in size. For the test, the sample is clamped tightly between two flanges fitted with circular seals, and water is applied to one surface at a

constant pressure for 72 hours. Once the exposure time ends, the specimen is split open so that the deepest point of water ingress can be measured. The volume of water that passes into the concrete can also be observed through the graduated burettes attached to the upper section of the testing setup (Figure 6).

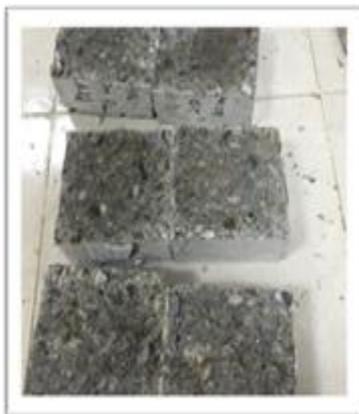
Fig. 7 Samples cut in half to check water penetration

The standard mix recorded a water penetration depth of 22 mm (Table 5). This relatively high penetration reflects the absence of fibres, meaning the mix had no mechanism to restrict crack widening or promote healing, and therefore showed no ability to seal the cracks (Figure 7).

Customer Sample Ref.	01	02	03
Age at test (days)	41		
Surface treatment	Wire brush		
Moisture Condition	Saturated Surface Dry		
Density (kg/m <sup>3</sup> ) [Moist]	2470	2460	2500
Maximum water penetration (mm)	34	13	19
Mean (mm)	22

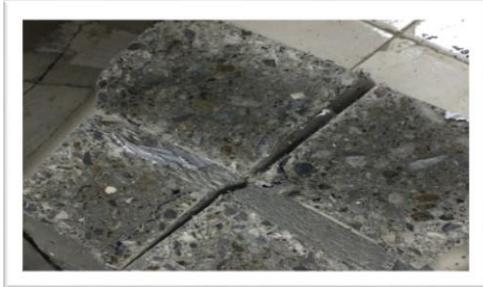
Fig. 8 Penetration level in the second batch of samples

Compared to the conventional mix, the 20-gram fiber-reinforced mix had an average water penetration depth of 16 mm. The presence of synthetic fibres is responsible for this decrease, suggesting that they assisted in keeping crack widths within a range where healing and crack sealing may occur (Figure 8).

Batch 2: Fibre-reinforced mix containing 20 g of synthetic fibres and 60 ml of superplasticizer. This batch recorded a water penetration depth of 16 mm (Table 6).

Customer Sample Ref.	04	05
Age at test (days)	41	
Surface treatment	Wire brush	
Moisture Condition	Saturated Surface Dry	
Density (kg/m <sup>3</sup> ) [Moist]	2480	2460
Maximum water penetration (mm)	11	20
Mean (mm)	16

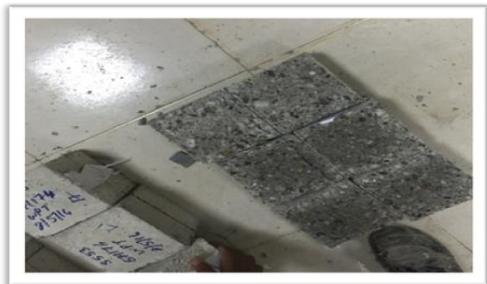
Fig. 9 Penetration level in the third batch of samples

The 30-gram fibre-reinforced samples showed an average water penetration depth of 18 mm, which is 2 mm higher than the 20-gram batch. This suggests that increasing the fibre content begins to negatively affect the mix by reducing workability and disrupting the hydration process during the curing stage. As a result, additional or wider cracks may form, falling outside the range that synthetic fibres can effectively control or support in terms of self-healing (Figure 9).

Customer Sample Ref.	06	07	08
Age at test (days)	41		
Surface treatment	Wire brush		
Moisture Condition	Saturated Surface Dry		
Density (kg/m <sup>3</sup> ) [Moist]	2530	2530	2520
Maximum water penetration (mm)	19	17	17
Mean (mm)	18

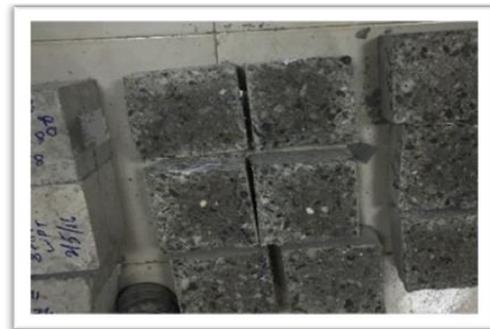
Fig. 10 Water penetration in the sample

Fibre-reinforced mix containing 40 g of synthetic fibres and 100 ml of superplasticizer. This batch recorded a water penetration depth of 22 mm (Table 8).

Customer Sample Ref.	09	10
Age at test (days)	41	
Surface treatment	Wire brush	
Moisture Condition	Saturated Surface Dry	
Density (kg/m <sup>3</sup> ) [Moist]	2520	2460
Maximum water penetration (mm)	25	17
Mean (mm)	21
