Evaluation of an Existing RBC Plant in Egypt

The study location is El-Manayel WWTP, located in Qalyubia governorate in Egypt, in an agricultural area North of El Khanka district.

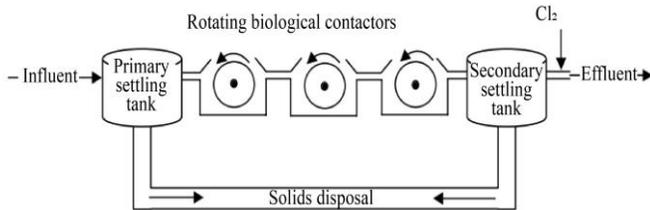
Fig. 1 Flow diagram of an RBC process[2]

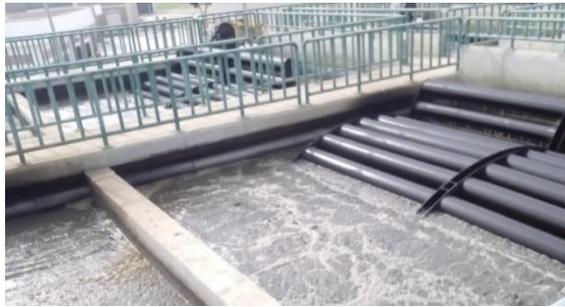
The MRBC consists of a number of cylindrical contactors, which are arranged circularly around a horizontal shaft. Contactors are partially immersed in the wastewater and driven by a rotational movement by a mechanical drive system consisting of a gear motor and chain drive. The percentage of submergence in MRBC is about 80%, as shown in Figure 2.

Fig. 2 Modified rotating biological contactor

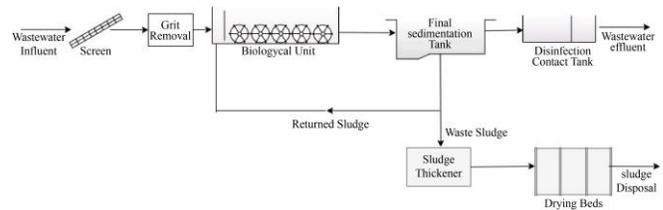
The components of the El-Manayel treatment plant include the inlet chamber, screens, grit removal chamber,

biological tanks, sedimentation tanks and chlorine and disinfection system. Besides the sludge units, thickeners, pumps, and drying beds are illustrated in Figure 3.

Fig. 3 Flow Diagram for El-Manayel WWTP

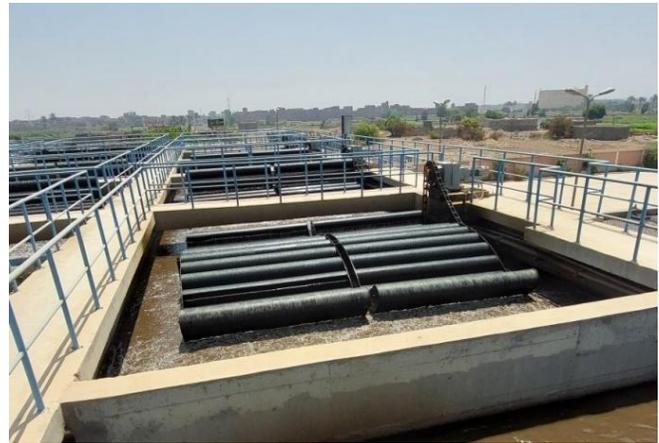
The plant contains four biological tanks; each tank contains 5 wheels, and each wheel consists of a shaft surrounded by cylinders loaded with discs, as shown in Figure 4. A mechanism that rotates the wheels consists of a motor and a drive chain connecting two gears, controlled by a gearbox powered by an electric motor. The level of aeration can be controlled by utilizing a variable-speed drive. Increasing or decreasing the rotor’s speed according to the actual oxygen demand.

Fig. 4 Biological units

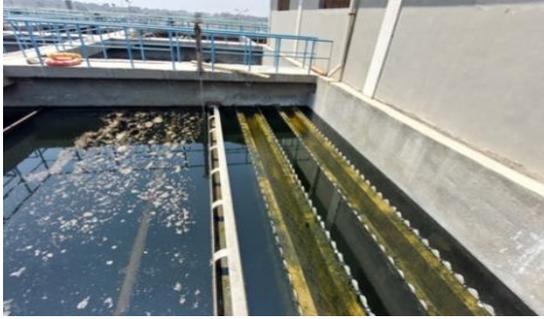
Fig. 5 Sedimentation tanks outlet channels

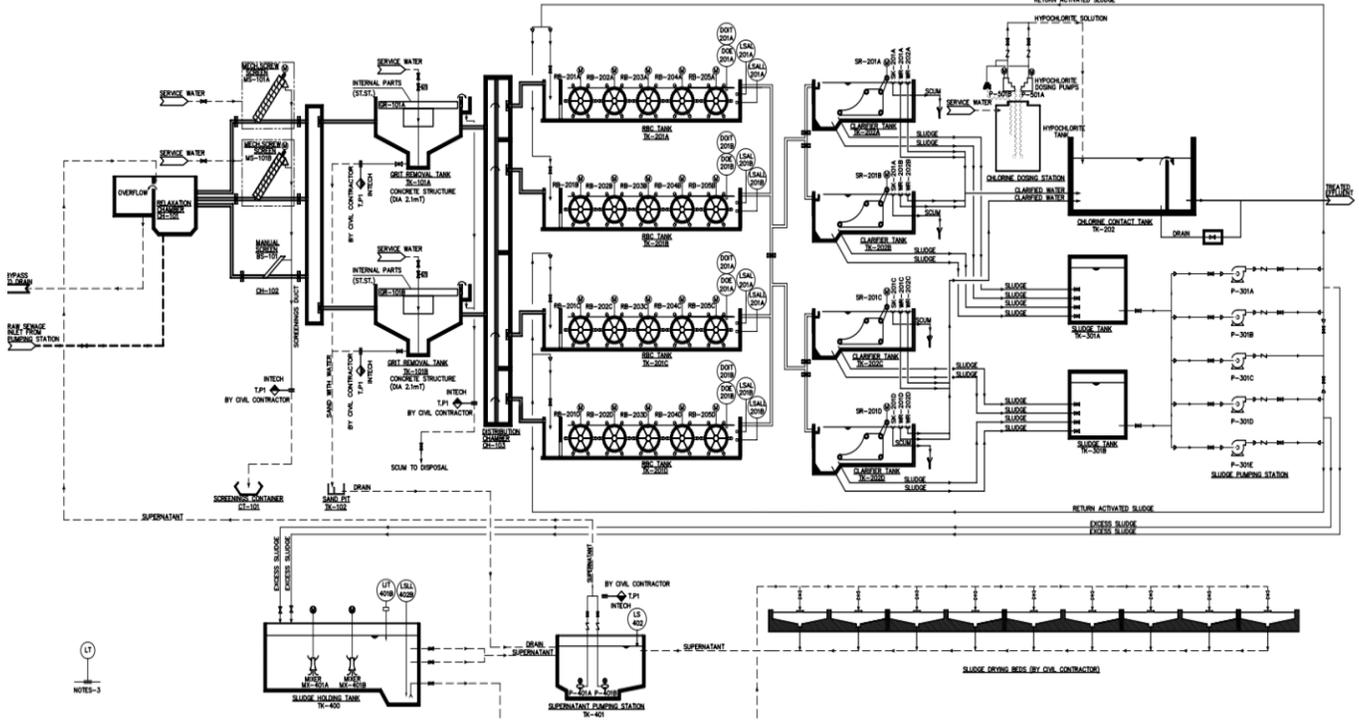
El-Manayel WWTP has been designed to treat 10000 m³/d of wastewater. After the preliminary treatment, the plant is split into two parallel biological treatment lines, as demonstrated in Figure 6.

Fig. 6 El-Manayel WWTP process flow diagram

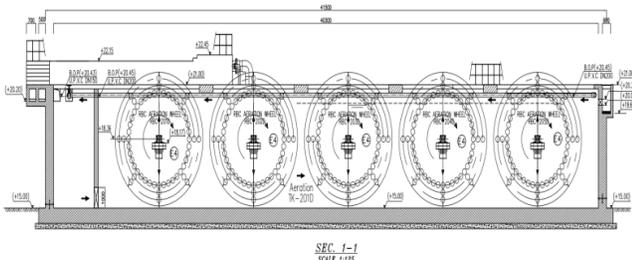
The axis of the RBC shaft is placed perpendicular to the direction of flow, and it rotates in the direction that causes the top of the media to move opposite to the direction of flow to minimize the short circuits, as demonstrated in Figure 7.

Fig. 7 Cross-section of the Biological Tank

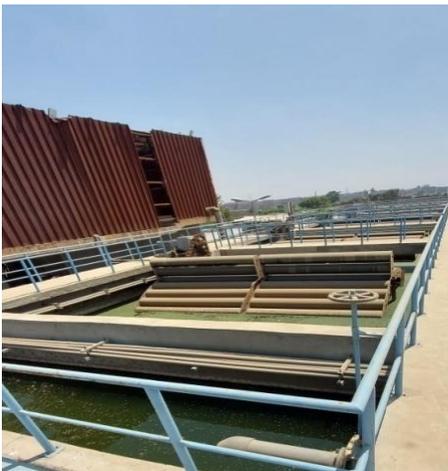
The Biological Tank number 1 was out of service, as shown in Figure 8, for more than six months due to repetitive failures in operating the rotating mechanism and the drive chain.

Fig. 8 Biological tank number 1 out of service

place repetitively, causing failure in the treatment system. Most of the identified issues were centered within the rotating mechanism in the biological units, consisting of a motor and a drive chain that rotates the MRBC wheels.

1. Implementing suitable maintenance and operation procedures for MRBC plants to achieve successful and safe operation.
2. Applying the O&M procedures on the MRBC plants in Egypt, as they all have a similar design to the design of the studied plant but with different capacities.
3. Preserving and improving the RBC plants in Egypt rather than transforming them into activated sludge.
4. MRBC plants can be implemented by using local manufacturing materials, which would decrease the capital cost and the maintenance cost.

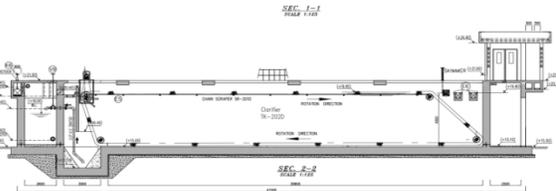
There are four final sedimentation tanks; each tank has a scrapper driven by a plastic chain conveyor, as shown in Figure 9. This non-metal chain system provides a reliable operation for the sedimentation tanks.

Fig. 9 Cross-section of sedimentation tank

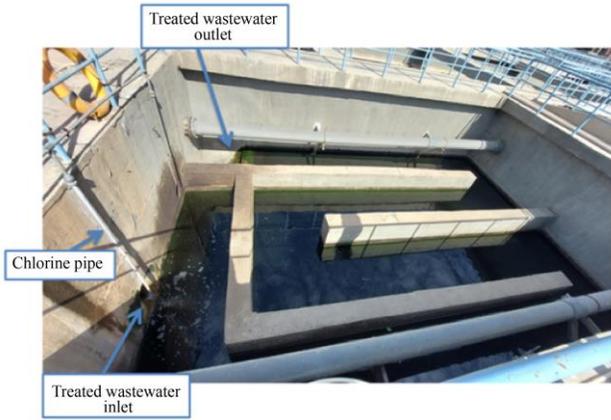
The hypochlorite dosing system is not working, and the operators use solid chlorine and mixing tanks instead. The Chlorination contact tank is in poor condition, and the chlorine is injected through two narrow pipes at the entry of the contact tank; these pipes end at a level higher than the water level, as demonstrated in Figure 10.

Fig. 10 Disinfection contact tank

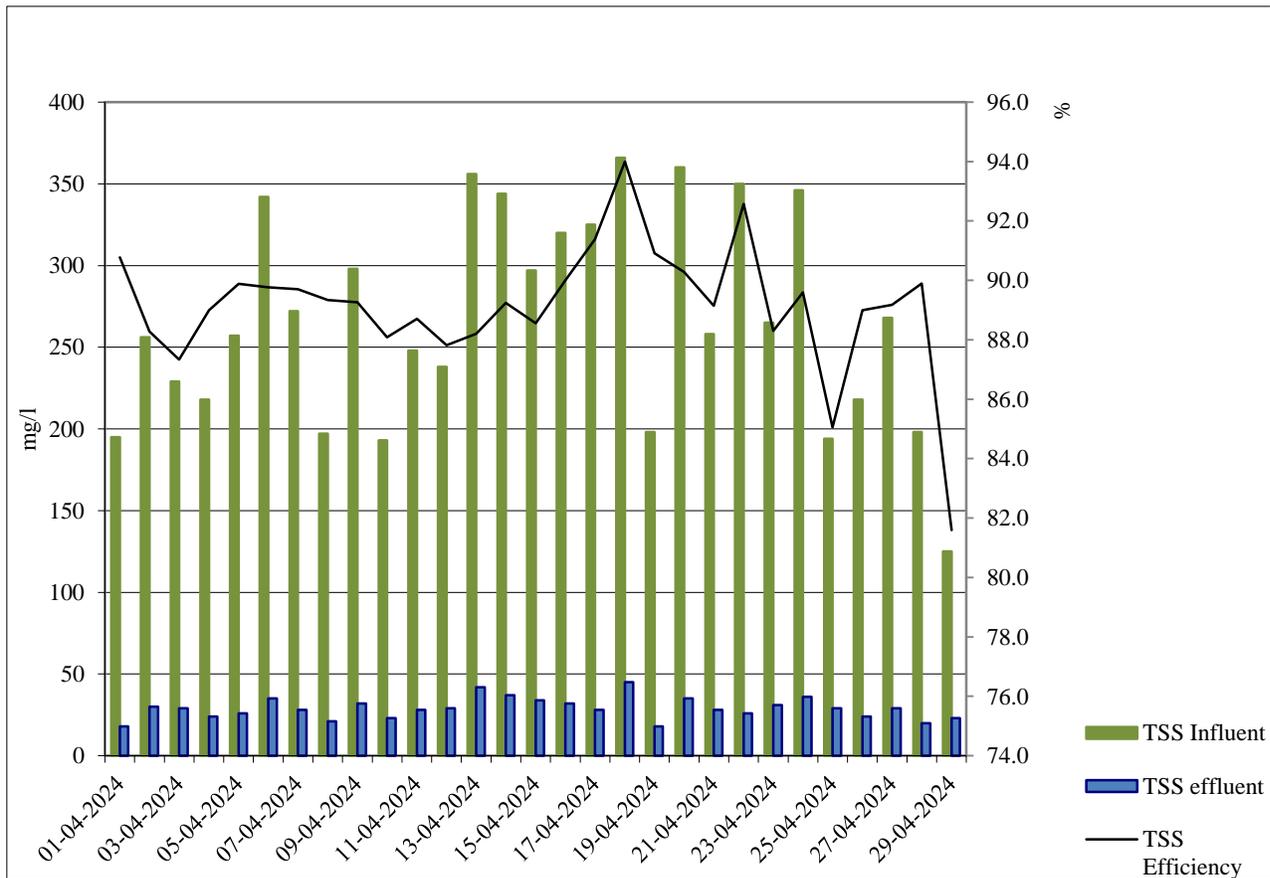
Figure 11 shows the TSS content in the influent raw wastewater and the treated effluent of the plant during April 2024.

Fig. 11 TSS Concentration in Influent and Final Effluent in April 2024

From the comprehensive assessment of the quality of the treated effluent, it was found that the treated effluent quality has achieved the requirements for the BOD₅ COD and TSS removal throughout the studied period.
