Original Article

Flexural Failure of Bamboo Reinforced Concrete Beams

Abstract - Flexural failure is a critical concern in bamboo-reinforced concrete, where bending forces cause tensile cracks to develop and propagate, ultimately leading to structural collapse. This research investigates the failure in terms of flexure of bamboo-reinforced concrete beams through experimental analysis, including compressive and tensile strength tests, three-point bending tests, and load-deflection and load-strain relationships. The results show that the beams achieved an average flexural stress of 37.7099 N/mm², with maximum displacements before failure ranging from 7.43017 mm to 9.42547 mm. Load-deflection analysis showed that the 1100 × 300 × 300 mm beams exhibited greater stiffness and lower deflection compared to the 1100 × 150 × 300 mm beams, reinforcing the role of beam size in flexural performance. Strain measurements confirmed that compression occurred at the top of the beams, while tension at the bottom led to crack initiation and eventual failure as the loads applied exceeded the material's capacity. The findings highlight the suitability of bamboo as an alternative material for reinforc

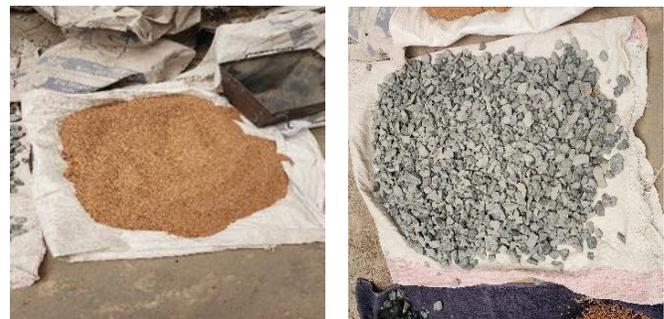
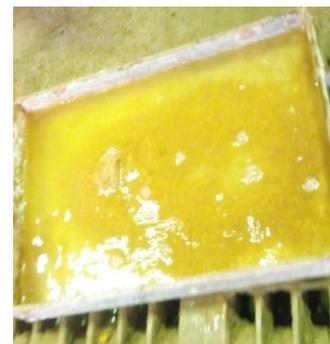
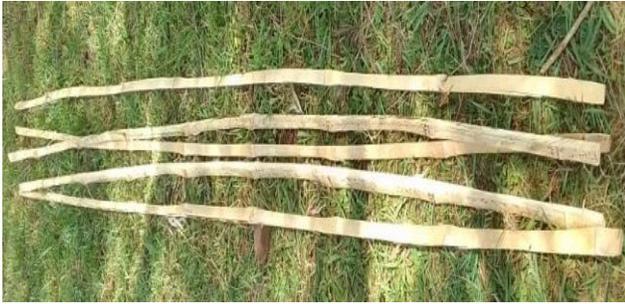
(d)
Fig. 1 Pictorial representation of (a) Fine aggregates, (b) Coarse aggregates, (c) Sikadur 32, and (d) Bamboo.

The type of cement used in this study was Ordinary Portland Cement (OPC) belonging to class CEM I and of strength 42.5 N and was acquired from Bamburi Cement Company. Other materials included fine aggregates and coarse aggregates, both sourced from a local reserve, as well as water, bamboo, and epoxy bonding agents (Sikadur 32). The bamboo bars were obtained from a research facility, and the Sikadur 32 agent was purchased from Sika Kenya Limited. The images below illustrate these materials.

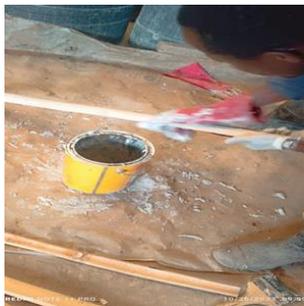
Fig. 2 Coating bamboo bars using Sikadur 32

The fine aggregates were subjected to sieving through a 4.75mm sieve, whereas the coarse aggregates were passed through a 20 mm mesh before the experimental work began. The aggregates were thoroughly washed and air dried afterwards to reduce silt content and other debris. The stirrups were also bent to the appropriate dimensions awaiting to enclose the bamboo bars. The epoxy bonding agent, Sikadur 32, was used to coat the bamboo culms in accordance with the designer’s specifications. Stirring of the agent mix was done appropriately to remove any entrapped air [23].

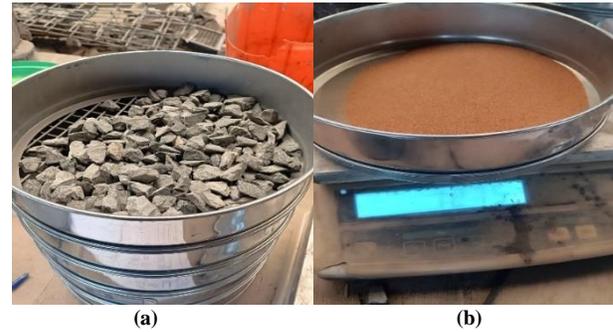
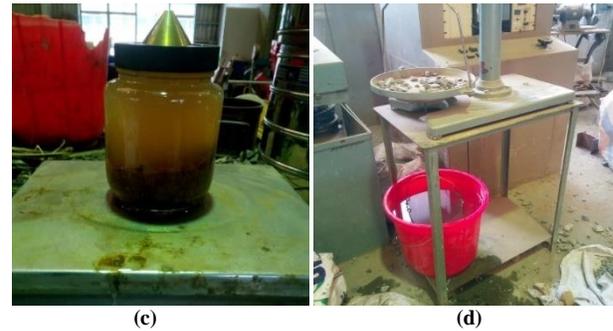
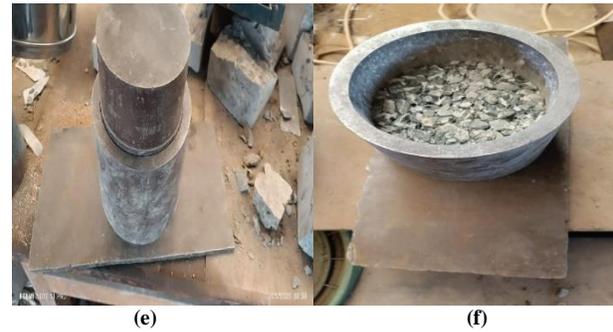
Fig. 3 Tests conducted on fine and coarse aggregates: (a) Particle size distribution of coarse aggregates, (b) Particle size distribution of fine aggregates, (c) Specific gravity of fine aggregates, (d) Specific gravity of coarse aggregates, (e), and (f) ACV setup.

The strength assessment of coarse aggregates under continuous load impact occurred through the Aggregate Crushing Value (ACV) test, which followed BS 812-110 standards. The fine and coarse aggregates were analyzed for water absorption following ASTM C128 standards while their specific gravity was tested using ASTM C127. The test results contributed to concrete density determination and porosity measurement, which shaped the mix design for future performance assessment. The Aggregate Impact Value (AIV) test was done to check how tough the coarse aggregates were

when subjected to sudden impact. This helps gauge their resistance to wear and tear. The specific gravity of both coarse and fine aggregate tests followed the ASTM C127 and ASTM C128 to see how dense they were compared to water. This is important for mix design since it affects concrete's overall weight and stability. Using these results, the water absorption was calculated.

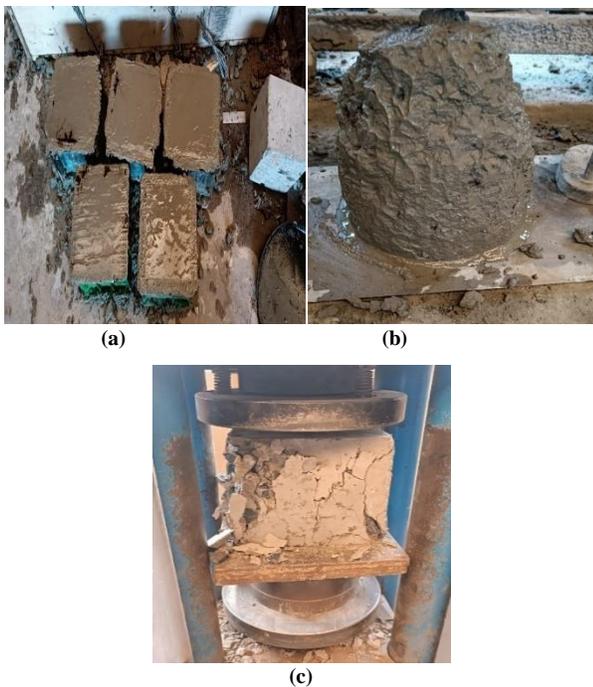
Fig. 4 Pictorial representation of: (a) Casting of cubes, (b) Slump test, and (c) Compressive strength test

The workability of the fresh concrete was obtained from the slump test following the ASTM C143, the purpose of which was to determine the right consistency for placement. The concrete was filled in a slump cone in three successive layers, and compaction was done carefully using a tamping rod in addition to each layer to remove any trapped air. Once filled, the cone was lifted, and the slump value was measured.

Cubes of dimension $100 \times 100 \times 100$ mm were subjected to compressive strength test in line with the ASTM C39 procedure. The cubes were placed in a curing tank and tested at 7 and 28 days. During testing, the cubes were placed in a Universal Testing Machine (UTM) and load was applied until failure. Additionally, a splitting tensile strength test following ASTM C496 was performed to analyse the concrete's resistance to tensile loads, and the results were recorded.

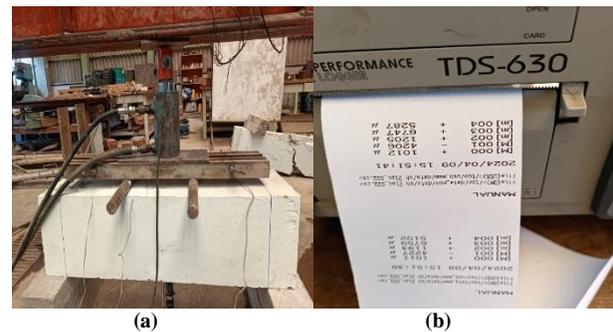
Fig. 5 Pictorial Representation of, (a) Concrete beam set up for the flexural test, and (b) Operation of the LVDT

In the test setup, both extremes of each beam were simply supported, with a concentrated load applied at the center. On increasing the load, deflection occurred on the beam, and cracks started to form in the zone of tension. The test was continued until ultimate failure to allow for the measurement of stiffness and ductility.

Linear Variable Differential Transformers (LVDTs) and strain gauges were used to capture the beam's structural response in real-time. LVDTs were used to gauge the deflection, while strain gauges monitored how different beam sections responded to the applied loads. From this, relationships between load-deflection and load-strain were developed. The relationships helped to understand how efficiently loads are transferred between the bamboo and concrete. These tests and relationships provided direct evidence of failure through crack patterns, modes of failure, and distribution of strain, as well as an understanding of causes of flexural failure, as researched by [24], such as bamboo slipping and failure in ductility. Some of the illustrations of the tests are shown below.

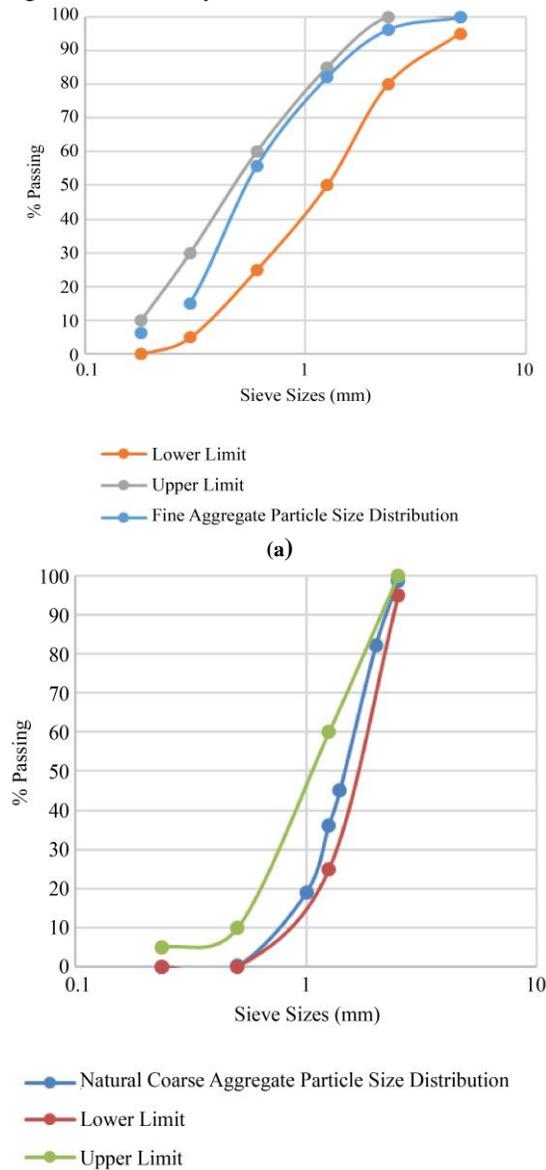
Fig. 6 Particle size distribution for, (a) Fine aggregates, and (b) Coarse aggregates

Fine and coarse aggregates underwent sieve testing according to the ASTM C136 method for analysis and yielded the following results. The test method revealed meaningful information about the size distribution and grading characteristics needed to produce a densely packed mixture. The gradation of the coarse aggregates shows an even distribution, with most particles passing the upper sieves (25 mm) and fewer in the lower sieves (2.36 mm).

This indicates a well-graded coarse aggregate that imparts higher strength to concrete. Similarly, the outcome indicates a well-graded fine aggregate that falls within the specified limits. The well-graded nature of the fine aggregates will ensure that the cement paste-to-aggregate bond is improved.

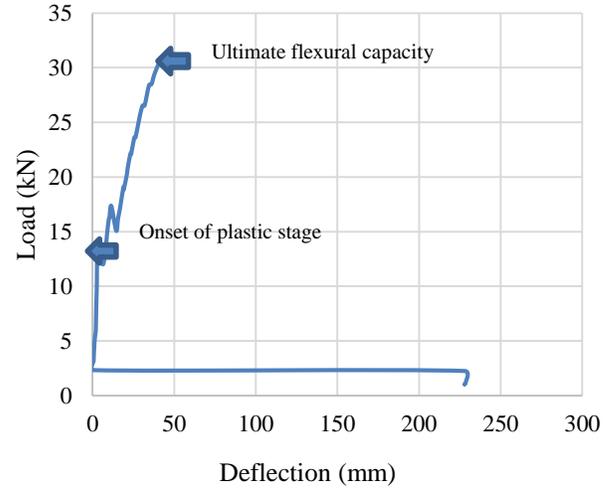
Fig. 7 Load vs deflection graph for 150 × 300 beam

The load-deflection graphs show the beam response to applied loads. The 150×300 mm beam displayed a clear transition from an initial linear phase, where the beam behaved elastically, to a non-linear phase. This pointed to the development of cracks and the progression into plastic deformation. The ultimate flexural capacity reached the graph's peak, beyond which the beam could no longer withstand additional loading. The $1100 \times 300 \times 300$ mm beam displayed similar behavior, the difference being the noticeably steeper initial gradient. This implies higher stiffness because of the increased cross-sectional area. The implication is that the larger beam will experience less deflection when you apply the same load, supporting the idea that depth plays a crucial role in flexural performance. As seen, deflection increased rapidly beyond the elastic limit, meaning that whereas the bamboo reinforcement accounts for some capacity of ductile behavior, the flexural strength of the beam is what enabled it to resist failure. The cracks present in the tension zone weaken the beam over time, leading to failure as the load exceeds the resistance capacity [25]. The strain readings at the top, bottom, and left corner align with previous research since compression occurs on top and tension bottomward. In the $1100 \times 150 \times 300$ mm beam, the transition from elastic to plastic deformation can be

- The load-deflection curves showed that the $1100 \times 300 \times 300$ mm beam had higher stiffness than the $1100 \times 150 \times 300$ mm beam, experiencing lower deflection for the same applied load. However, both beams exhibited similar non-linear behavior as cracks developed, indicating the onset of failure.

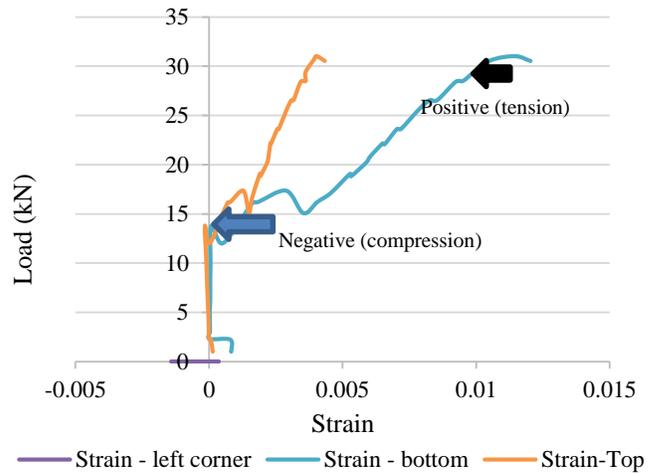
Fig. 8 Load vs strain graph for 150 × 300 beam

seen as strain values increase, particularly in the bottom section where tensile forces are most significant. The left corner strain provides information on how strain is distributed across the beam's width. The larger 300×300 mm beam was similar but with lower strain values due to its increased stiffness. The negative strain at the top highlights compression, while the positive strain at the bottom confirms the tensile forces that cause crack formation. As the strain increased beyond the elastic range, failure occurred. The strain distribution is consistent with flexural failure mechanics, whereby cracks develop due to the inability of the tension zone to withstand increasing stress.

- Strain analysis confirmed that compression occurred at the top while tension built up at the bottom, causing crack formation. The top strain had a negative value range, while the bottom strain was all positive, with strain values ranging from -0.005 to 0.015 for the $1100 \times 150 \times 300$ mm beam and 0 to 0.008 for the $1100 \times 300 \times 300$ mm beam.

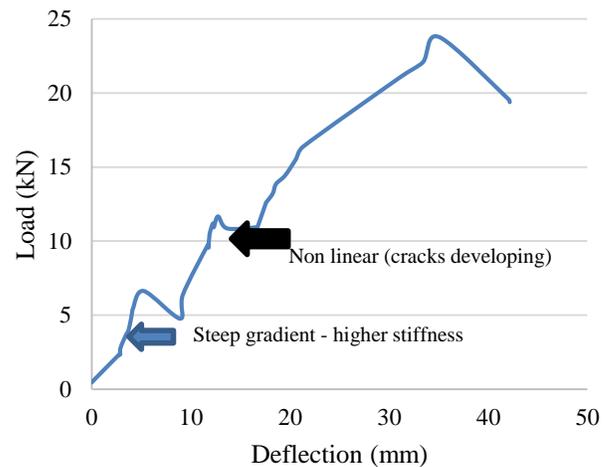
Fig. 9 Load vs deflection graph for 300 × 300 beam

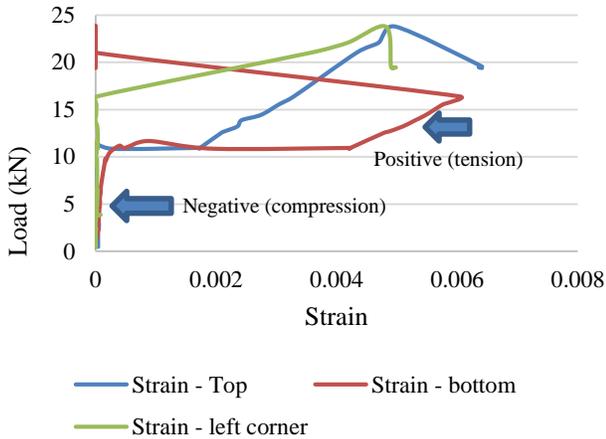
Fig. 10 Load vs strain graph for 300×300 beam
